ENGINEERING CONDITION SURVEY AND STRUCTURAL  
INVESTIGATION OF MARSH ARCH BRIDGE  
FORT RILEY, KANSAS

# ENGINEERING CONDITION SURVEY AND STRUCTURAL INVESTIGATION OF MARSH ARCH BRIDGE, FORT RILEY, KANSAS

Final Report

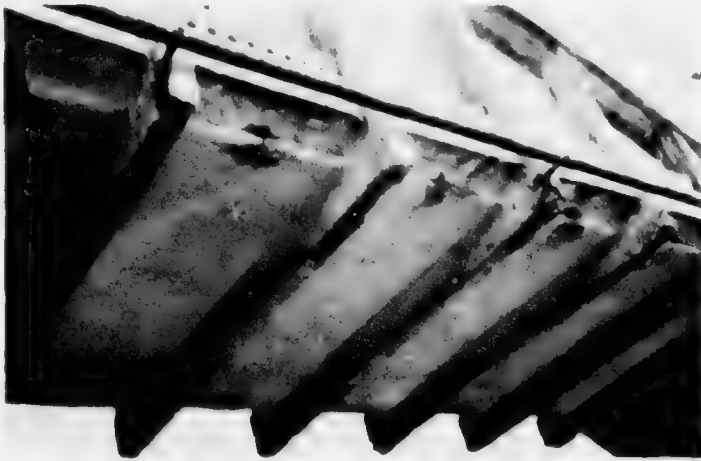
- b. Floor beams. Severe deteriorations (cracking and spalling) appeared on all floor beams. Concrete crack widths as large as 1/8 in. were noted. A feeler gage blade inserted into one of the cracks went approximately 2 in. which was probably less than half the depth of the crack. Spalling of original concrete at the junctions of vertical hanger and floor beam was prevalent (Figure 6a). Rebar and steel elements were exposed showing stratified corrosion (Figure 6b and 6c). At the surface of the crack, leaching of the calcium hydroxide and other material compounds was noted (Figure 7). It is believed that the vertical hanger and floor beam joints are the most critical areas. The failure of some of these joints appears imminent.

a. Overall view.  
(The utility line  
is anchored to the  
floor beams)

b. Exposure of rebar  
and steel elements

c. Closeup of a  
typical deteriorated  
floor beam

Figure 6. Floor beams showing spalling and cracking

33. It is, therefore, recommended that an early action toward replacement of this bridge (both super- and substructures) be initiated.

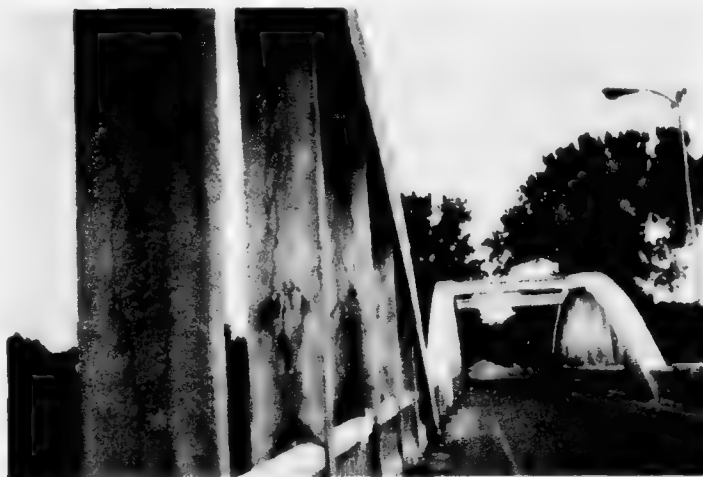
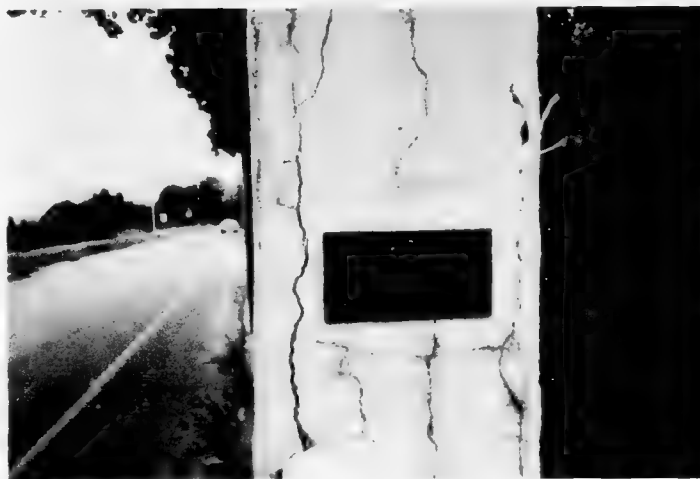
- c. Vertical hangers. Vertical cracks appeared on almost all hangers (Figure 8). It can be seen from Figure 8 that the vertical cracks extended to the full height of the hangers. Corrosion stains at the surface of the cracks were apparent.

a. Overall view

b. Closeup view

Figure 8. Cracks in vertical hangers

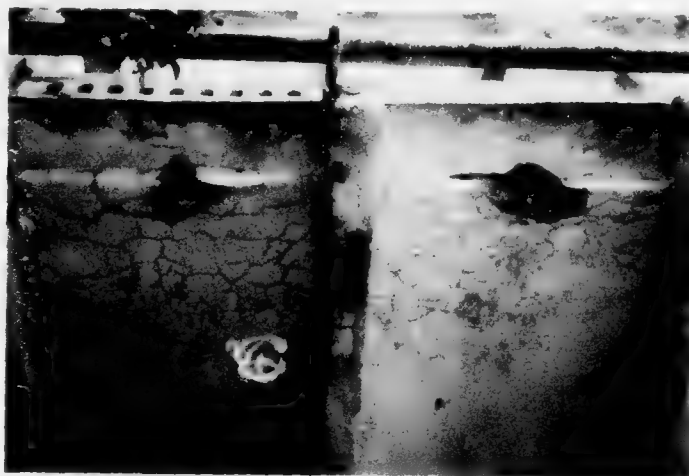
- d. Deck. There are many deteriorated areas as viewed from the underside of the bridge deck. Large spalling of the shotcrete surface and the original concrete was noted on several locations (Figure 6b). Figure 9 shows the pattern or map crackings on the underside of the bridge deck. They vary in width from barely visible to well-defined openings. Most of the drain holes on the bridge deck were partially clogged and dark colored deposits appeared around the drain holes.

Figure 9. Underside of bridge deck

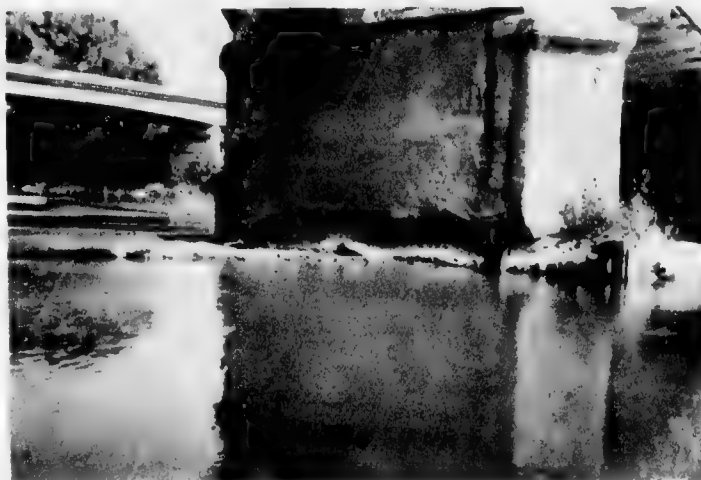
- e. Abutments and pier. Cracking and spalling of shotcrete surface and original concrete were noted on the abutments and pier (Figures 10 and 11). Pattern crackings were also noted. Figure 11 shows the severe erosion at the base of the pier.

Figure 11. Severe erosion at base of pier

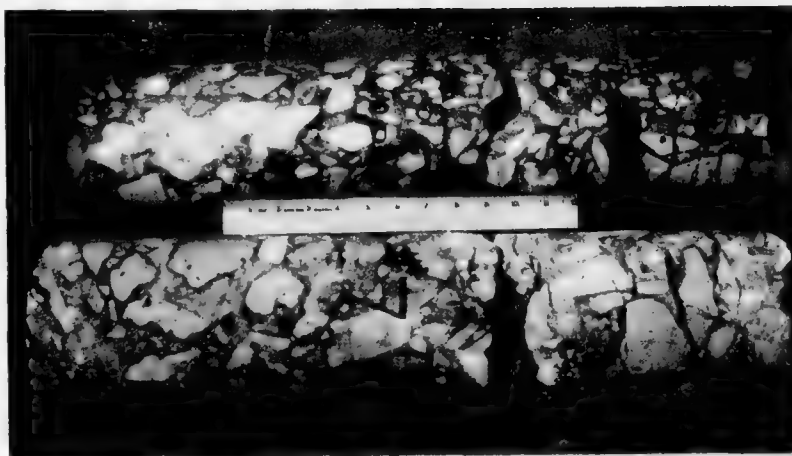
a. South end  
(cores 1 and 2)

b. North end  
(cores 5 and 7)

c. North end  
(core 6)

Figure 12. Concrete cores drilled from abutment

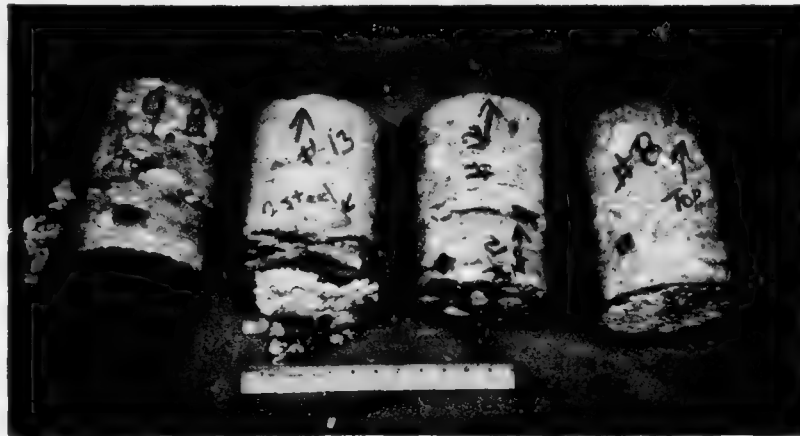
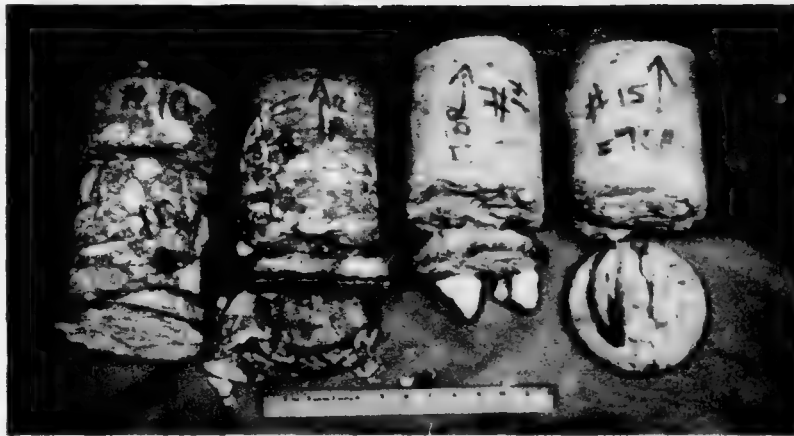
a. South span  
(cores 8, 9,  
12, and 13)

b. North span  
(cores 10, 11,  
14, and 15)

c. Closeup show-  
ing cracks

Figure 14. Concrete cores drilled from bridge deck

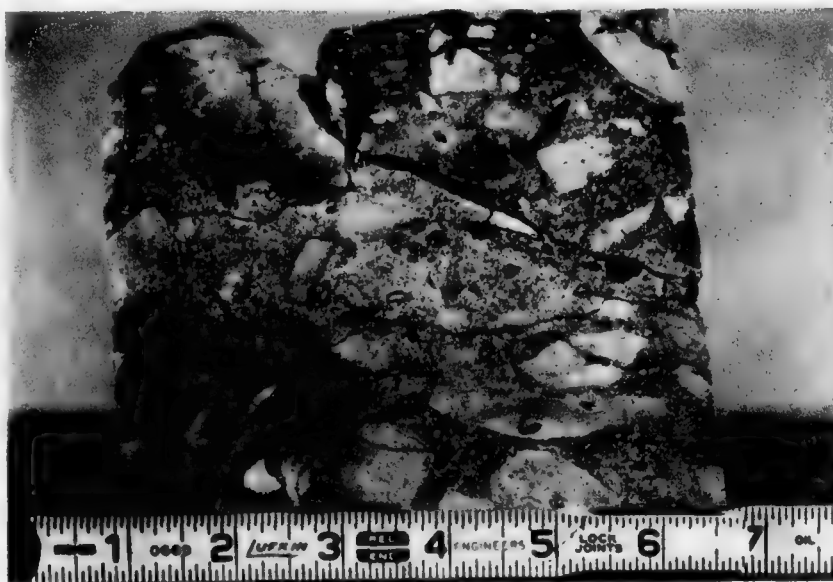
8. The sawed and ground surfaces of portions of cores 3 and 6 are shown in Figure A15. These surfaces clearly show the presence of reaction rims on some chert particles and on some limestone particles. These rims, plus the detection of dried alkali-silica gel on broken surfaces, are clear evidence that both alkali-silica and alkali-carbonate rock reactions have occurred. A powder immersion mount of the gel showed it to consist of transparent and brownish types with refractive indices below 1.544. The transparent type shows a salt and pepper type texture under crossed nicols and is probably crystalline.

a. Sawed and ground surface of a portion of core 3 from an arch section. The aggregate particles showing dark rims are chert that have reacted in the alkali-silica reaction. About half normal size.

b. Section of core 6 from the North Abutment prepared as above. The surface shows several limestone coarse aggregate particles with reaction rims (upper, lower areas). These were involved in an alkali-carbonate rock reaction.

Figure A15. The sawed and ground surfaces of portions of cores 3 and 6.
